Implementation of Best Management Practices to Reduce Nonpoint Source Loadings to Onion Creek Recharge Features

Antioch Cave BMP and Aquifer Recharge Facility

Final Report

December 16, 1998

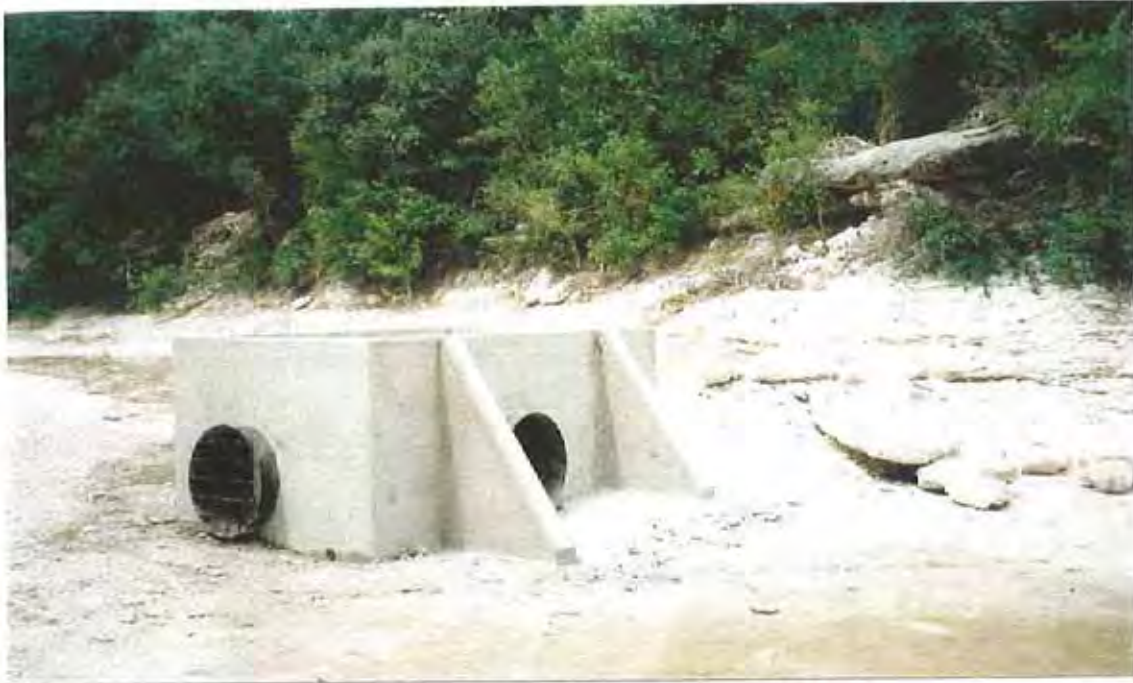
Antioch Cave BMP as installed in 1997.

Don Rauschuber and the Project Manager, Ron Fieseler met several times to discuss alternative BMP installations. These discussions led to the conceptualization and development of an innovative and unique design which would achieve the project goals and address other concerns. The new BMP would: (1) withstand the forces imposed by high volume and high velocity flood conditions, (2) control the quality of water entering the aquifer, (3) allow for maximum recharge, (4) provide for safe and easy flow monitoring and water quality sampling, (5) prevent unauthorized entry into the cave, (6) have low maintenance requirements, (7) be reliable and easy to use, (8) have minimum physical and visual impact on Onion Creek and the adjacent property, and (9) present few, if any, potential hazards or danger to persons navigating Onion Creek during flow conditions. Figure 2-6 is a photograph of the BMP as installed.

Engineering drawings were prepared and submitted to the TNRCC (see Appendix D). The BMP consists of a concrete vault measuring approximately 7' high, 8' wide, and 12' long. It has a two piece lid with a steel manhole access in each piece. Two 36" diameter flanged steel spools are imbedded in the vault, one on the south side and one on the east side. The spool on the south side has a 36" butterfly valve bolted on the inside of the vault and a steel grill welded on the outside. The butterfly valve is opened and closed by means of a compressed air operated cylinder. The other spool currently has a solid steel plate bolted to it, but is available for installation of a second valve if necessary. To ensure continued recharge during low flow conditions, a 4" PVC pipe is located at the lowest part of the south side and serves as a "weep hole". Two PVC pipes exit the north side of the vault. The 6" diameter pipe is the vent line, which allows the vault to "breathe" as necessary to prevent undue pressure build-up and to allow atmospheric conditions to exist in the vault. A 4" diameter pipe conducts air hoses into the vault to operate the valve cylinder. A 2" diameter PVC pipe leads from the 4" pipe around the base of the vault to the southwest corner and contains monitoring and sampling hoses. Two buttresses were added to the east wall for extra strength. A 6'x6' monitoring shed has been build on steel post legs on the north creek bank and has electric power service. The shed contains the air compressor, bubbler flow meter, a refrigerated automatic water sampler, and other monitoring equipment.

The 36" butterfly valve remains closed during non-flow conditions. Any spring flow, seepage, or low flow recharges via the 4" weep hole. When flooding occurs or whenever the creek is in a flow condition, the valve will remain closed during "first flush" conditions. This first flush condition contains heavy sediment loads, high bacteria counts, and large quantities of trash, debris, and organic material. Once conditions have improved, based on visual observations and turbidity measurements by District personnel, the air compressor will be turned on and the valve opened to allow recharge to occur. The valve will remain open as long as the water level in Onion Creek is approximately one foot deep or greater. Should subsequent flood events and/or first flush pulses occur which increases the turbidity, sediment load, or trash and debris content, or if some hazardous condition presents itself, the valve will be closed until conditions warrant re-opening the valve to continue recharge.
