Recharge and Water-Quality Controls for a Karst Aquifer in Central Texas

Brian A. Smith and Brian B. Hunt

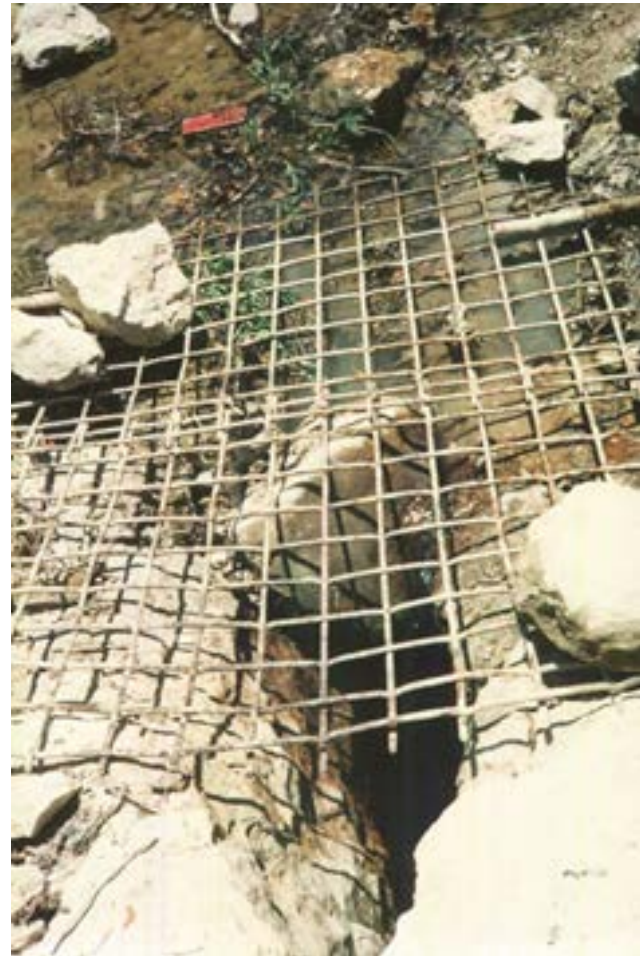
Fig. 2 Photograph ca. 1996 showing recharge and the entrance to Antioch Cave before the BMP was constructed. The debris over the entrance and also sedimentation within the cave decrease the amount of recharge entering the cave (Photograph from Fieseler 1998)

When District staff became aware of the existence of Antioch Cave, they quickly realized the significance of the cave for recharge to the Edwards Aquifer. Figure 2 is a photograph of the entrance to Antioch Cave prior to construction of the BMP. In 1992, the District began discussions with TNRCC about using federal 319(h) funds for conducting studies on Onion Creek and constructing a BMP at Antioch to improve the quality and increase the quantity of water entering the cave. Construction began on the BMP in August 1997 and was operationally completed by December 1997. A final report on the project was issued in December 1998 (Fieseler 1998). The BMP that was constructed was a steel-reinforced concrete vault. The BMP was situated directly over the cave entrance and is approximately 2 m (7 ft) high, 2.4 m (8 ft) wide, and 3.7 m

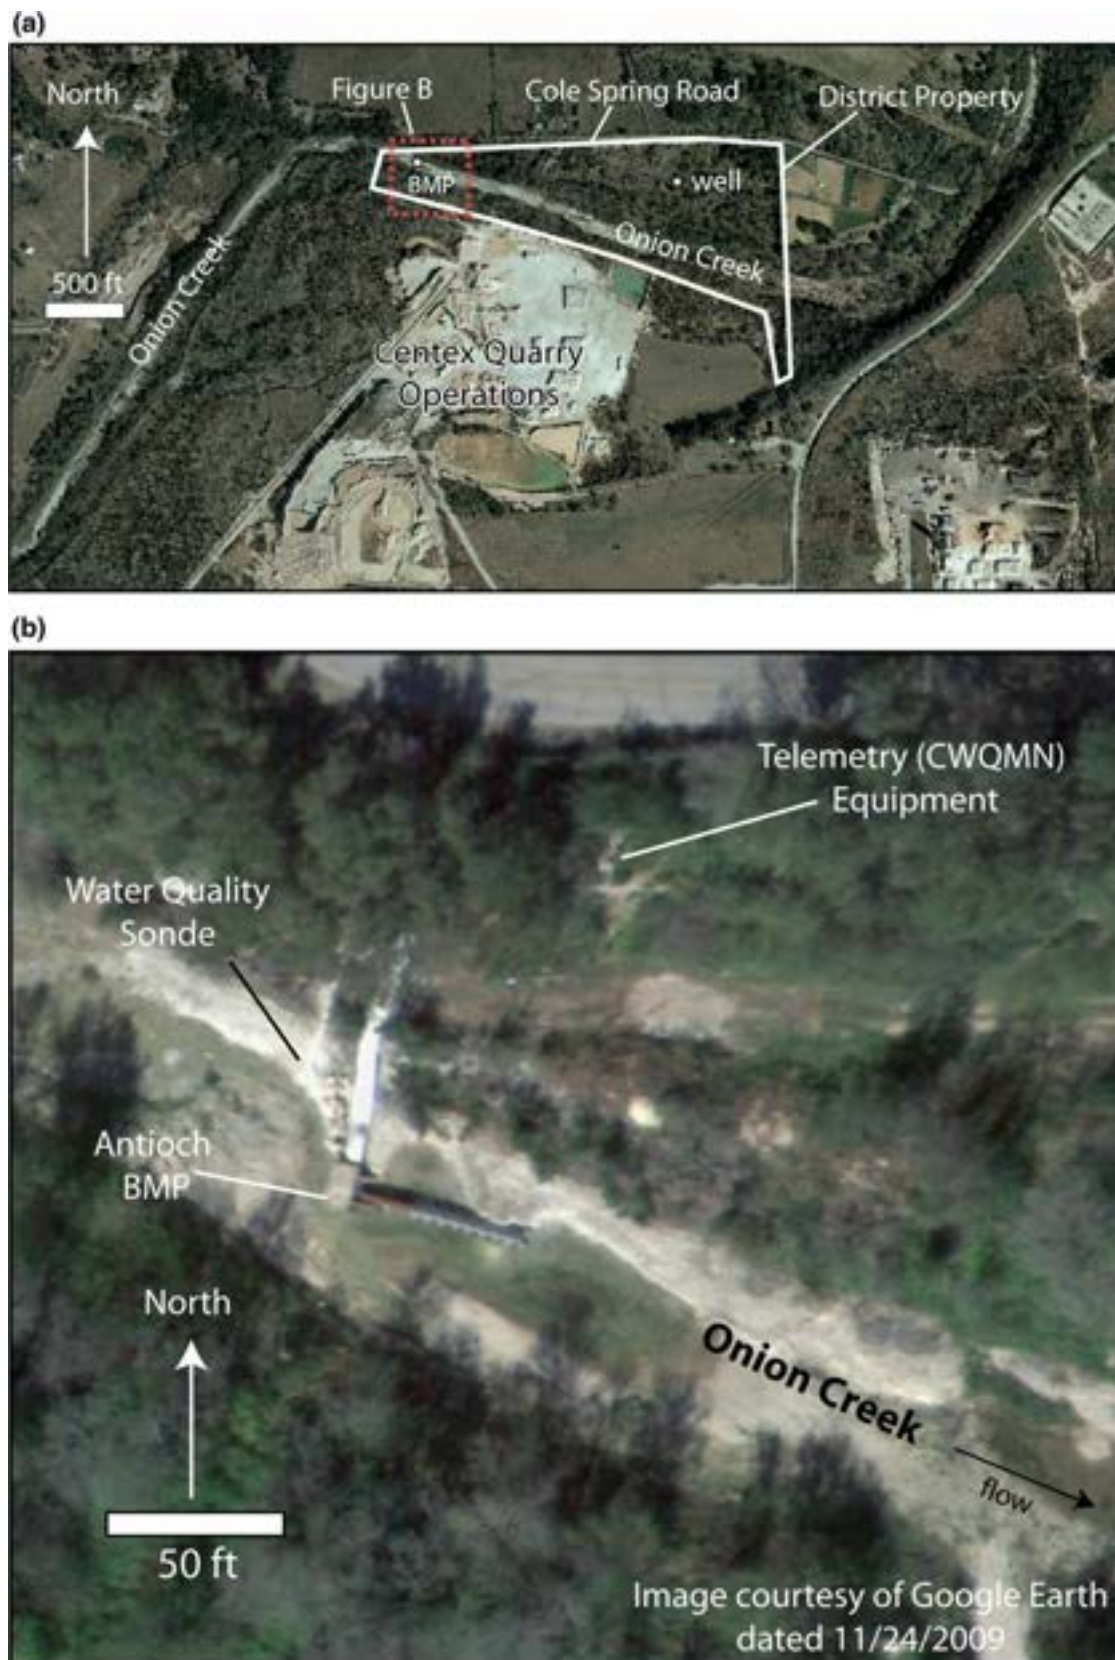
Fig. 3 a Aerial photograph showing major features near Antioch Cave including Onion Creek. b Close-up of aerial photograph showing the BMP after the upgrade

(12 ft) long. Figure 3 is an aerial photograph of the study site showing the location of the upgraded BMP in the bed of Onion Creek. Figure 4 is a schematic cross section of Onion Creek showing the BMP and a portion of Antioch Cave. The BMP has two steel manhole accesses on top and two 91 cm-(36-in.) diameter spools to hold 91-cm diameter (36-in.) pneumatically operated butterfly valves. Only one valve was installed during the original project, and the other spool was sealed with a steel plate. Air hoses connected the valve to a 1-ft by 1-ft by 2-ft concrete box on the north bank of Onion Creek. From this box, the valve could be opened using either an air compressor or a tank with compressed air. A 4-in. diameter PVC pipe was the conductor pipe for air hoses from the valve in the BMP to the concrete box. In addition, a 6-in. PVC pipe connected the BMP to the concrete box to allow air from the cave to vent to the surface when water is flowing into the cave entrance. Such venting prevents undue pressure build-up in the BMP and allows more water to recharge the aquifer.

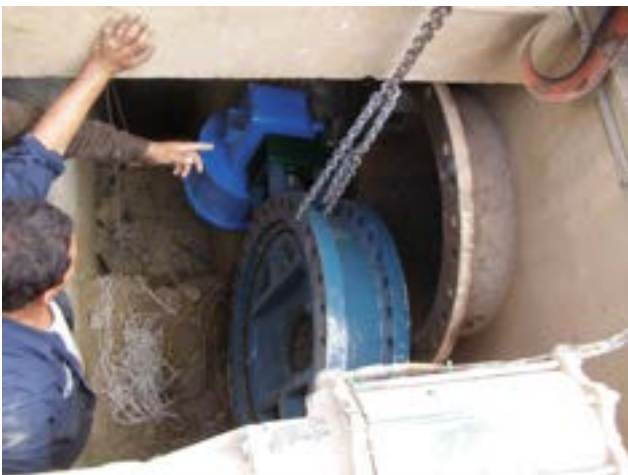
Fig. 8 Installation of second valve (automated) on Antioch BMP

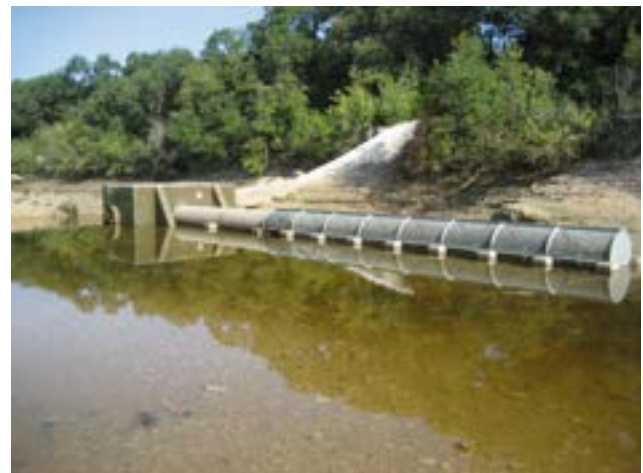
Fig. 9 View of Antioch BMP following upgrade completion. View looking upstream

An Isco 2150 velocity meter was installed near the midpoint of the 5-m (16-ft) long pipe. This velocity meter measures flow of water into the second valve. From the velocity data, a volume of flow can be calculated by multiplying the velocity by the cross-sectional area of the pipe. By measuring the volume of water entering the system when the valve is first opened following a flow event, the mass of storm contaminants prevented from entering the aquifer when the valves are closed can be calculated (Eq. 1—Calculation of Contaminant Reduction). Figure 9 is a photograph of the completed system.

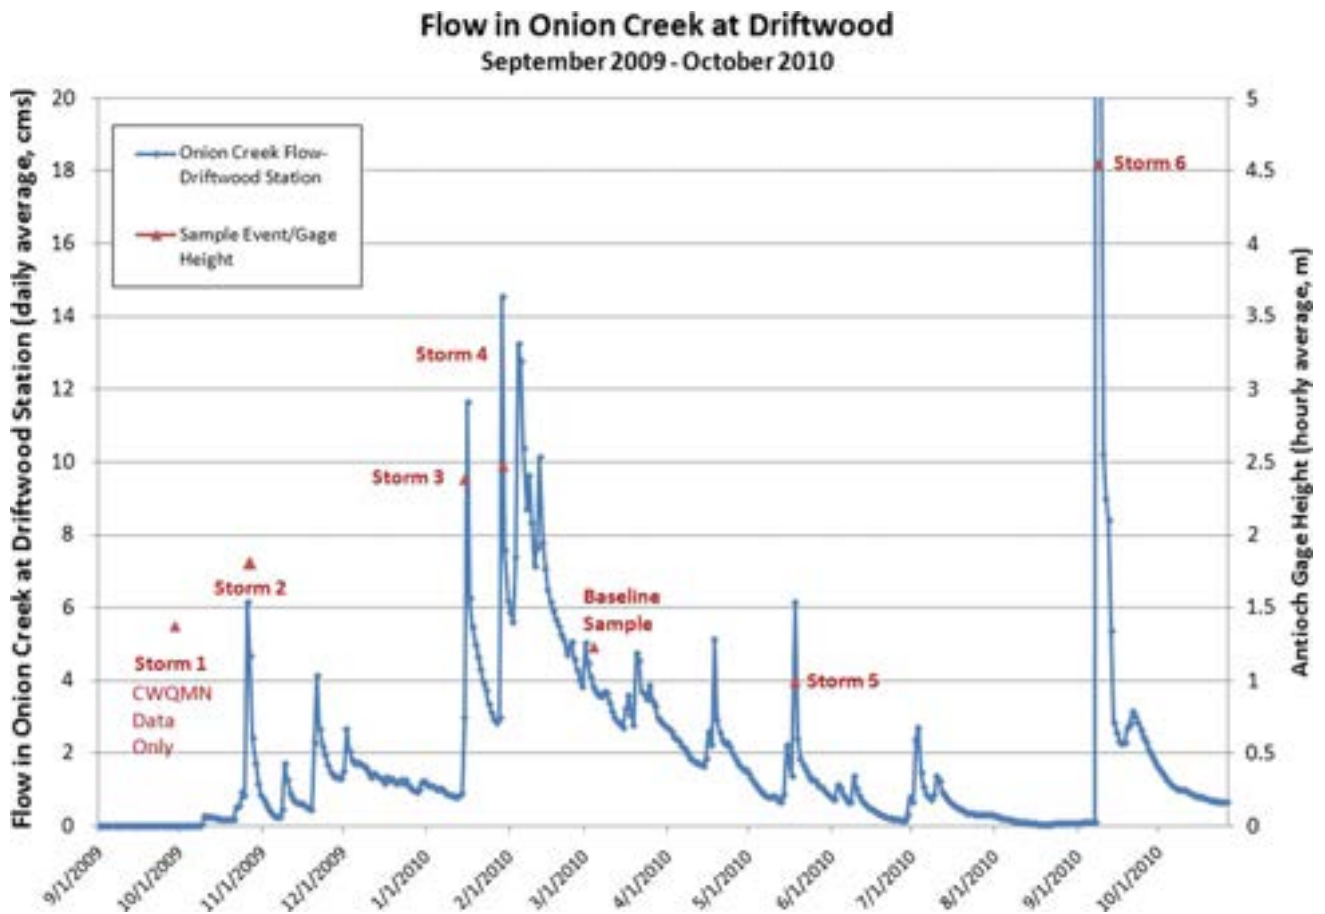
Fig. 10 Storm events sampled for this project are shown superimposed on a hydrograph of Onion Creek at the USGS Driftwood station from August 2009 to October 2010. The Driftwood station is about 21 km (13 miles) upstream of the Antioch Cave site

A summary of the six storm events recorded at the Antioch CWQMN site is presented in Fig. 10, which includes data from flow in Onion Creek at the U S Geological Survey (USGS) Driftwood station and maximum gage height at the Antioch CWQMN. Table 1 is a compilation of CWQMN and laboratory data shown in a chart format for each of the six storm events. Laboratory data include turbidity, nitrogen from nitrate and nitrite, total phosphorus, suspended solids, and total dissolved solids. A description of each of the six storm events is provided below.

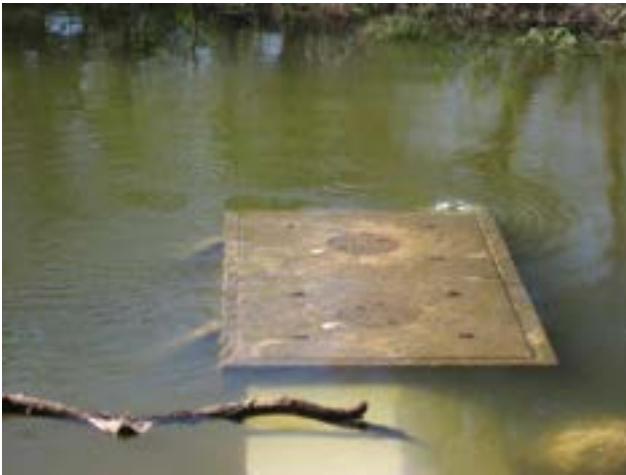
Fig. 11 Photograph of the top of the BMP about 8 h past the peak storm pulse on October 27, 2009, with a whirlpool near the corner of the vault due to water entering the original valve

October 26, 2009. This followed a very wet September, as described in Sect. 5.1.1, that had a rainfall total of about 330 mm (13 in.) over much of the recharge and contributing zones. Total rainfall in October was about 170 mm (6.5 in.) as measured at the District office in Manchaca, Texas. The maximum gage height at Antioch during this storm event was 2.0 m (6.2 ft). Turbidity reached a peak of 782 NTU at the very beginning of the storm pulse which quickly declined to less than 50 NTU within 50 min. Conductivity values spiked initially, then declined sharply, then rose steadily before leveling off for the remainder of the storm event. Figure 11 is a photograph showing water flowing in Onion Creek and the top of the BMP about 8 h past the peak storm pulse on October 27, 2009.

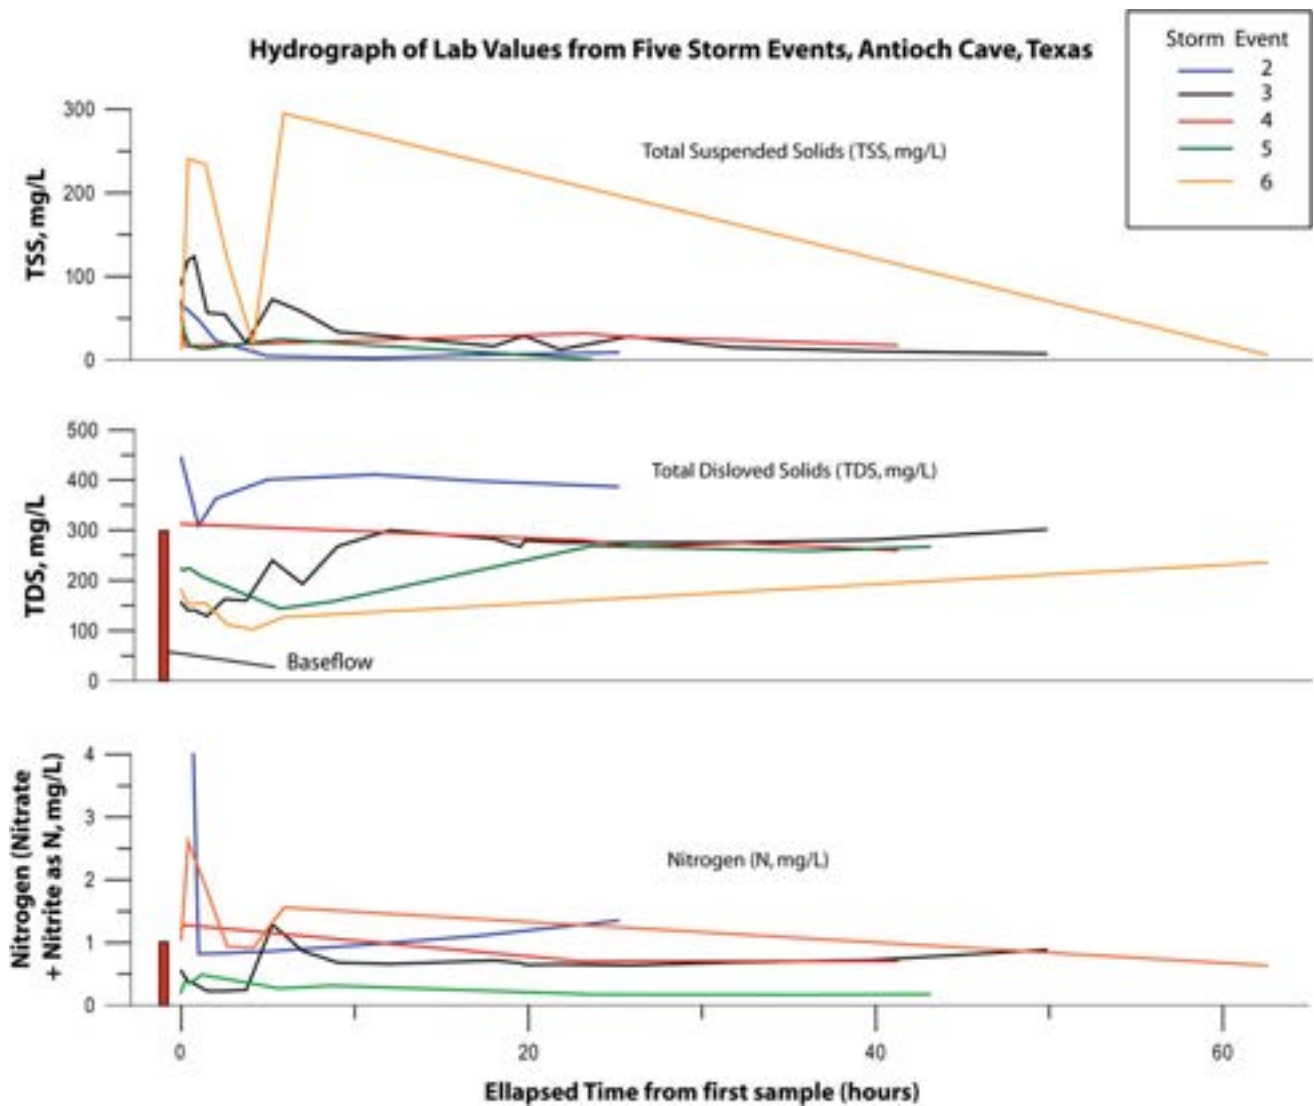
Fig. 13 Hydrograph of laboratory analytical results for five storm events at Antioch Cave. Also shown are the results from the baseflow sample as a *bar graph*. TSS was below the detection level for the baseflow sample

Figure 13 shows the results of laboratory analyses of samples from five storm events. Values for a given parameter vary considerably during the first 10 h of the storm event. Values tend to either rise or fall slightly after the first

10 h. This pattern applies to each of the five storm events. A sample was collected from Onion Creek at Antioch on March 4, 2010, that is considered to be representative of baseflow conditions. Laboratory analytical results for TDS, nitrogen (nitrate/nitrite), and TSS were 299, 1.01 mg/L, and below detection level, respectively. The trends of each of these parameters for each storm event show that over time, the values are heading in the direction of the baseflow sample values.
